Alligator Point Coastal Resiliency Alternatives Analysis

Funded by the Florida Department of Environmental Protection (Florida Resilient Coastlines Program grant) and the Northern Gulf of Mexico Sentinel Site Cooperative.

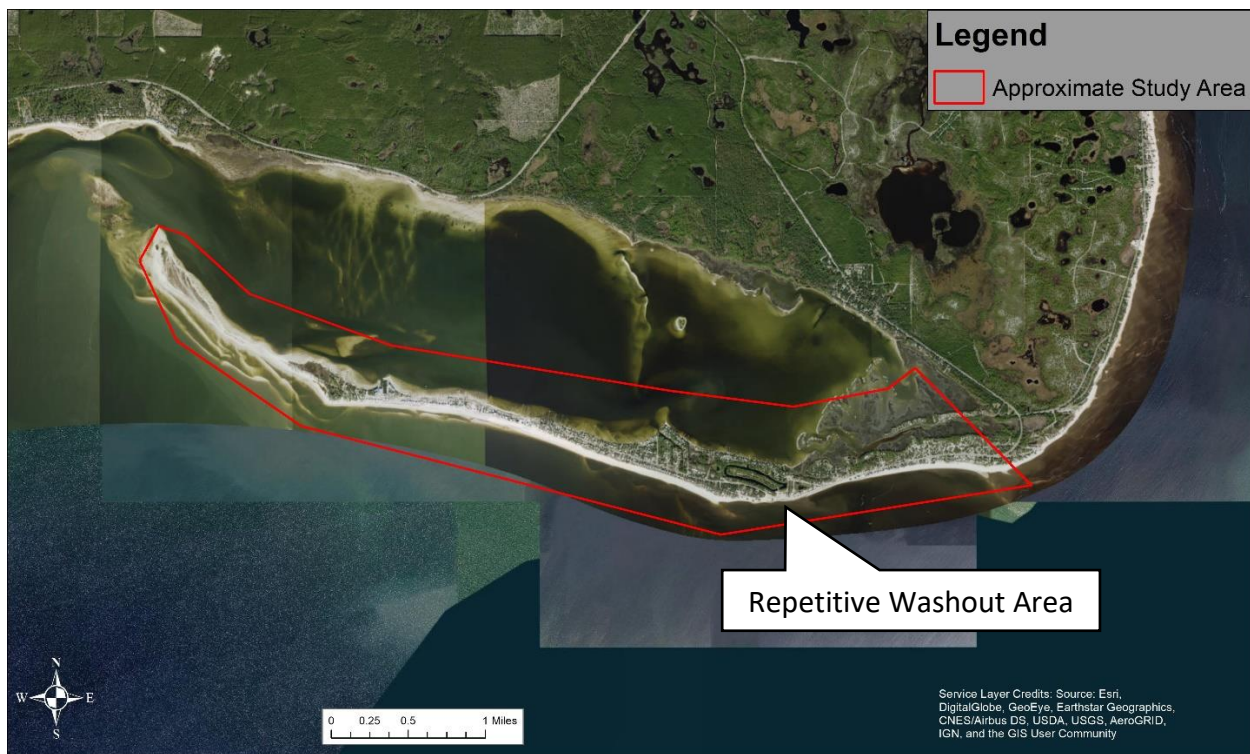
Figure 1: Map illustrating the boundaries (red line) of the Alligator Point study area, as well as the location where Alligator Drive frequently gets damaged by large storm events.

See **Figure 1** below for a map of the study area.

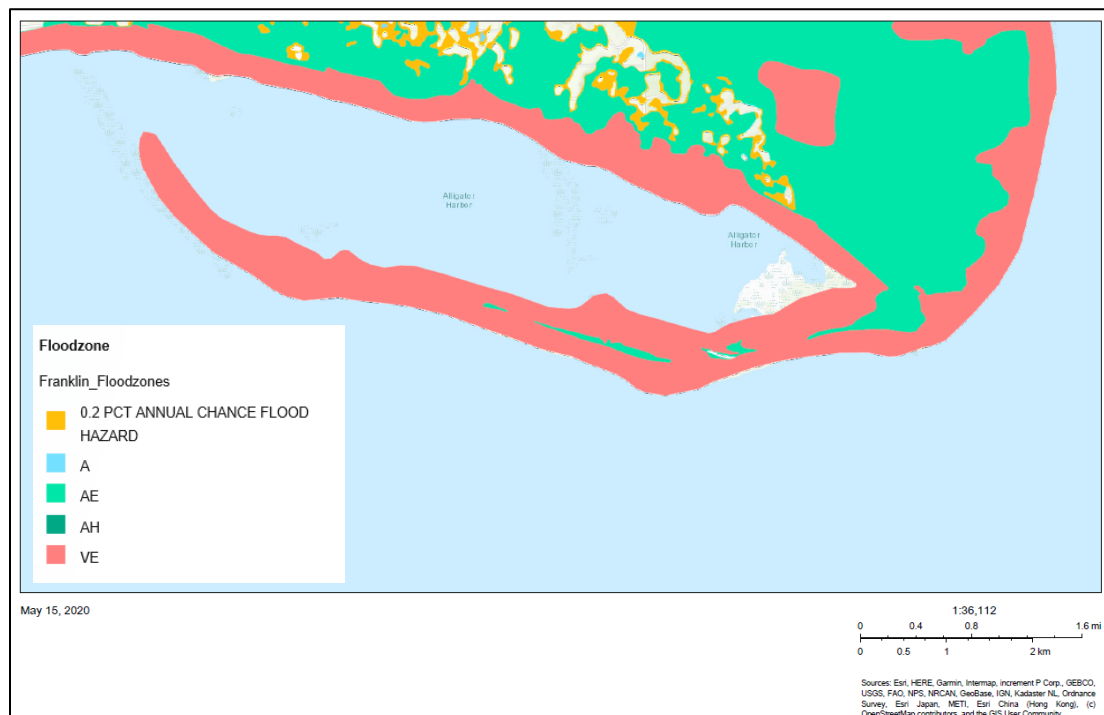
Figure 8: This map shows the FEMA flood hazard zones for the study area. (Source: ARPC n.d.)

Figure 7 below presents predicted inundation by storm surge for various storm. Much of the study area will be inundated during a Category 1 hurricane. **Figure 8**, which follows, presents FEMA flood zones. Most of the study area is Coastal High Hazard Area (referred to as the velocity or “VE zone”), which corresponds to areas subject to inundation by the 1-percent-annual-chance flood event with additional hazards due to storm-induced velocity wave action.

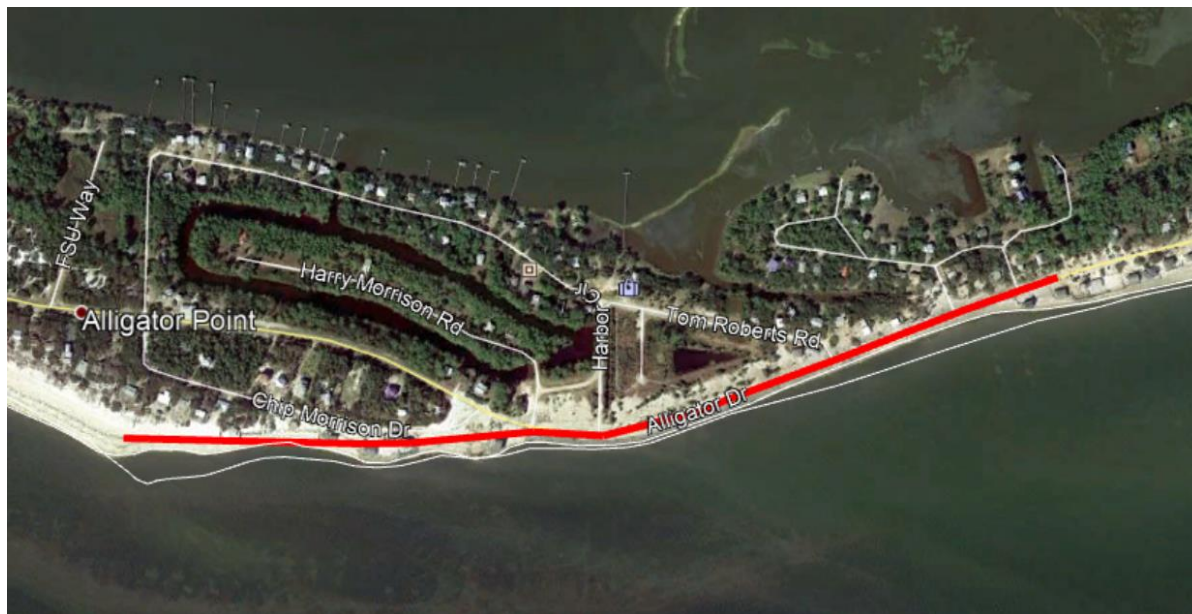
Figure 10: Alligator Point Existing Eroded Shoreline

Based on a review of 2020 imagery, significant damage is evident along an approximate 0.9-mile length of shoreline as shown in the **Figure 10** below.

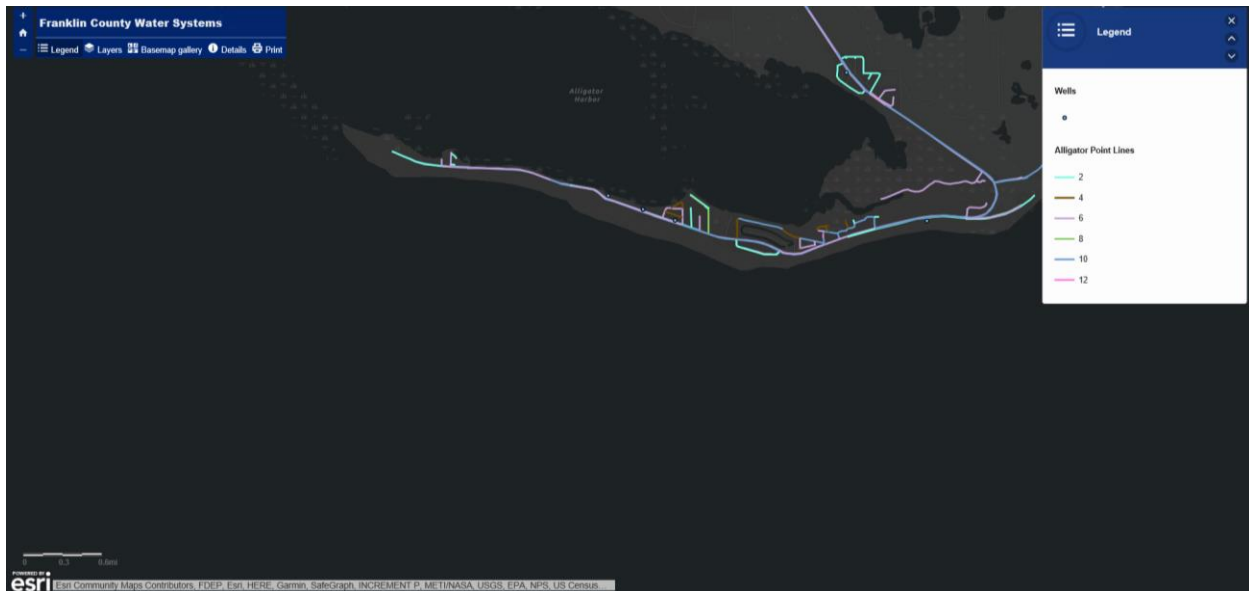
Figure 148: The water system that serves Alligator Point is a critical asset to the local community (ARPC 2018).

but has since been expanded to include two additional ground source tanks to support increasing community needs. In total, the APWRD provides service to nearly 640 customers, 30 percent of whom are full time residents. Not surprisingly, local business centers including Harbor Point Realty and Alligator Point Marina are among customers generating the greatest water usage rates within the district. A portion of this water main that feeds this system extends along Alligator Drive in the area where significant erosion has been occurring.

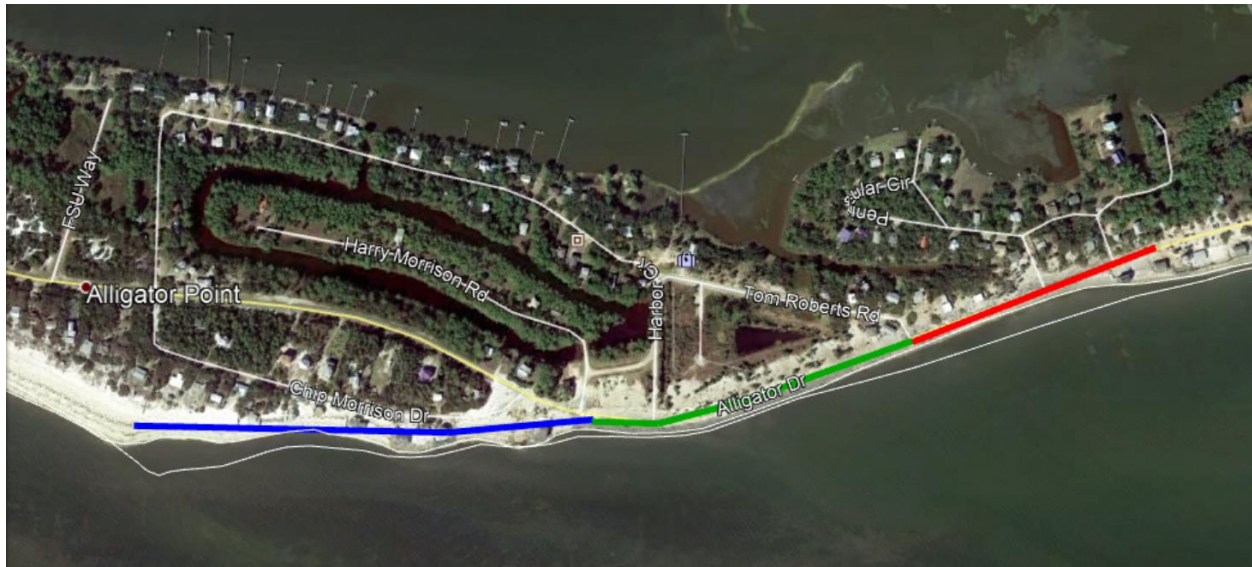
Figure 159: Alligator Point Critically Eroded Beach Segments

Considering the impending threats to the community including public safety, economic and ecological concerns, this assessment focused on the approximate 1-mile stretch of beach fronting the roadway subject to repetitive washout. This focus area is also further delineated in order to evaluate the relative urgency and risk level associated with different segments along this stretch that are useful for setting project priorities. The limits of the evaluation area are shown on **Figure 19**.

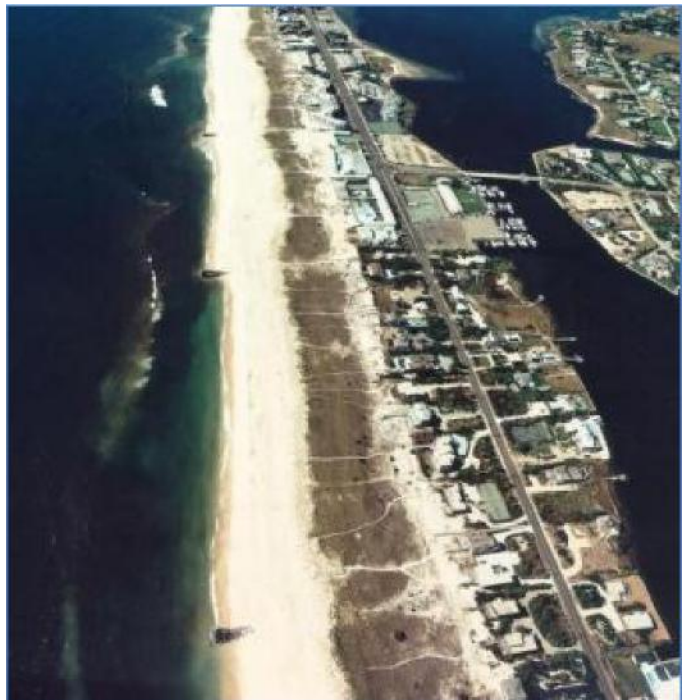
Figure 25: Aerial Photo of Typical Groin Protection

Groins are structures that extend perpendicular from the beach at various lengths and terminating as a straight-line or branching out in a “T” shape nearshore. In general, these structures are designed to limit longshore sediment transport (i.e., sediment movement along the shore) and can be designed to create pocket beaches (i.e., tombolo formations) or sawtooth-shaped beaches (as pictured above; **Figure 25**), depending on spacing and specific design. As mentioned, groins themselves do not prevent erosion from other process (i.e., onshore-offshore sediment transport, storm events). However, longshore sediments trapped by groins are often enough to make up for losses from storm events or offshore movement. This sediment trapping ability must be carefully balanced in groin designs to prevent deficient sediment transport to adjacent areas. As a result, these structures can be difficult to permit or may require substantial background investigations to meet permitting requirements.

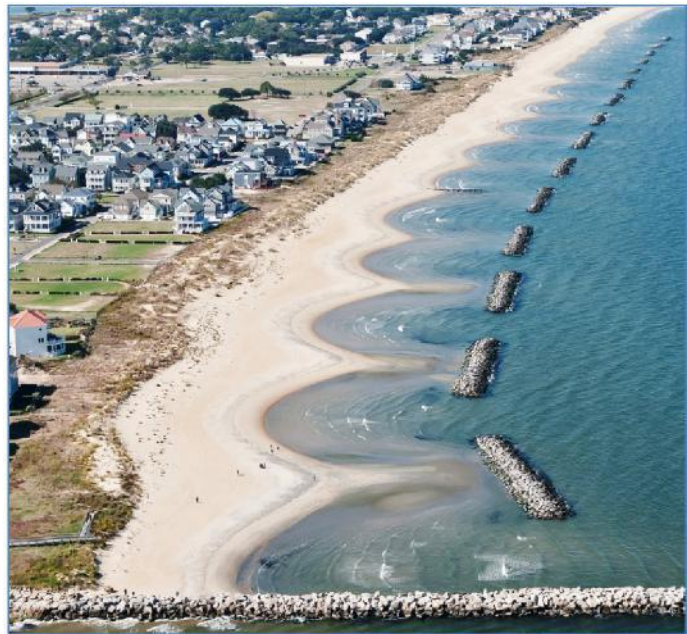
Figure 26 Aerial Photo of Nearshore Breakwater Protection

Breakwaters are structures positioned parallel to the shoreline that help to reduce onshore-offshore sediment transport by reducing wave energy and subsequent sediment suspension, and by trapping suspended sediments on the shoreward side of the structure. Just as with groin structures, the spacing and design of breakwaters can lead to varying shaped beaches or shorelines. For example, segmented breakwaters such as those pictured to the right (**Figure 26**) positioned nearshore and with adequate spacing can behave like groins, forming pocket beaches or tombolo formations. In general, however, the magnitude and frequency of these hump-shaped formations including the smaller (i.e., salient formations) and larger (i.e., tombolo formations) sized humps along the shoreline vary as a function of breakwater length and gap spacing. As with groins, breakwaters may promote sediment accretion over longer time scales but are not immune to losses during storms and as a result of longshore sediment transport.

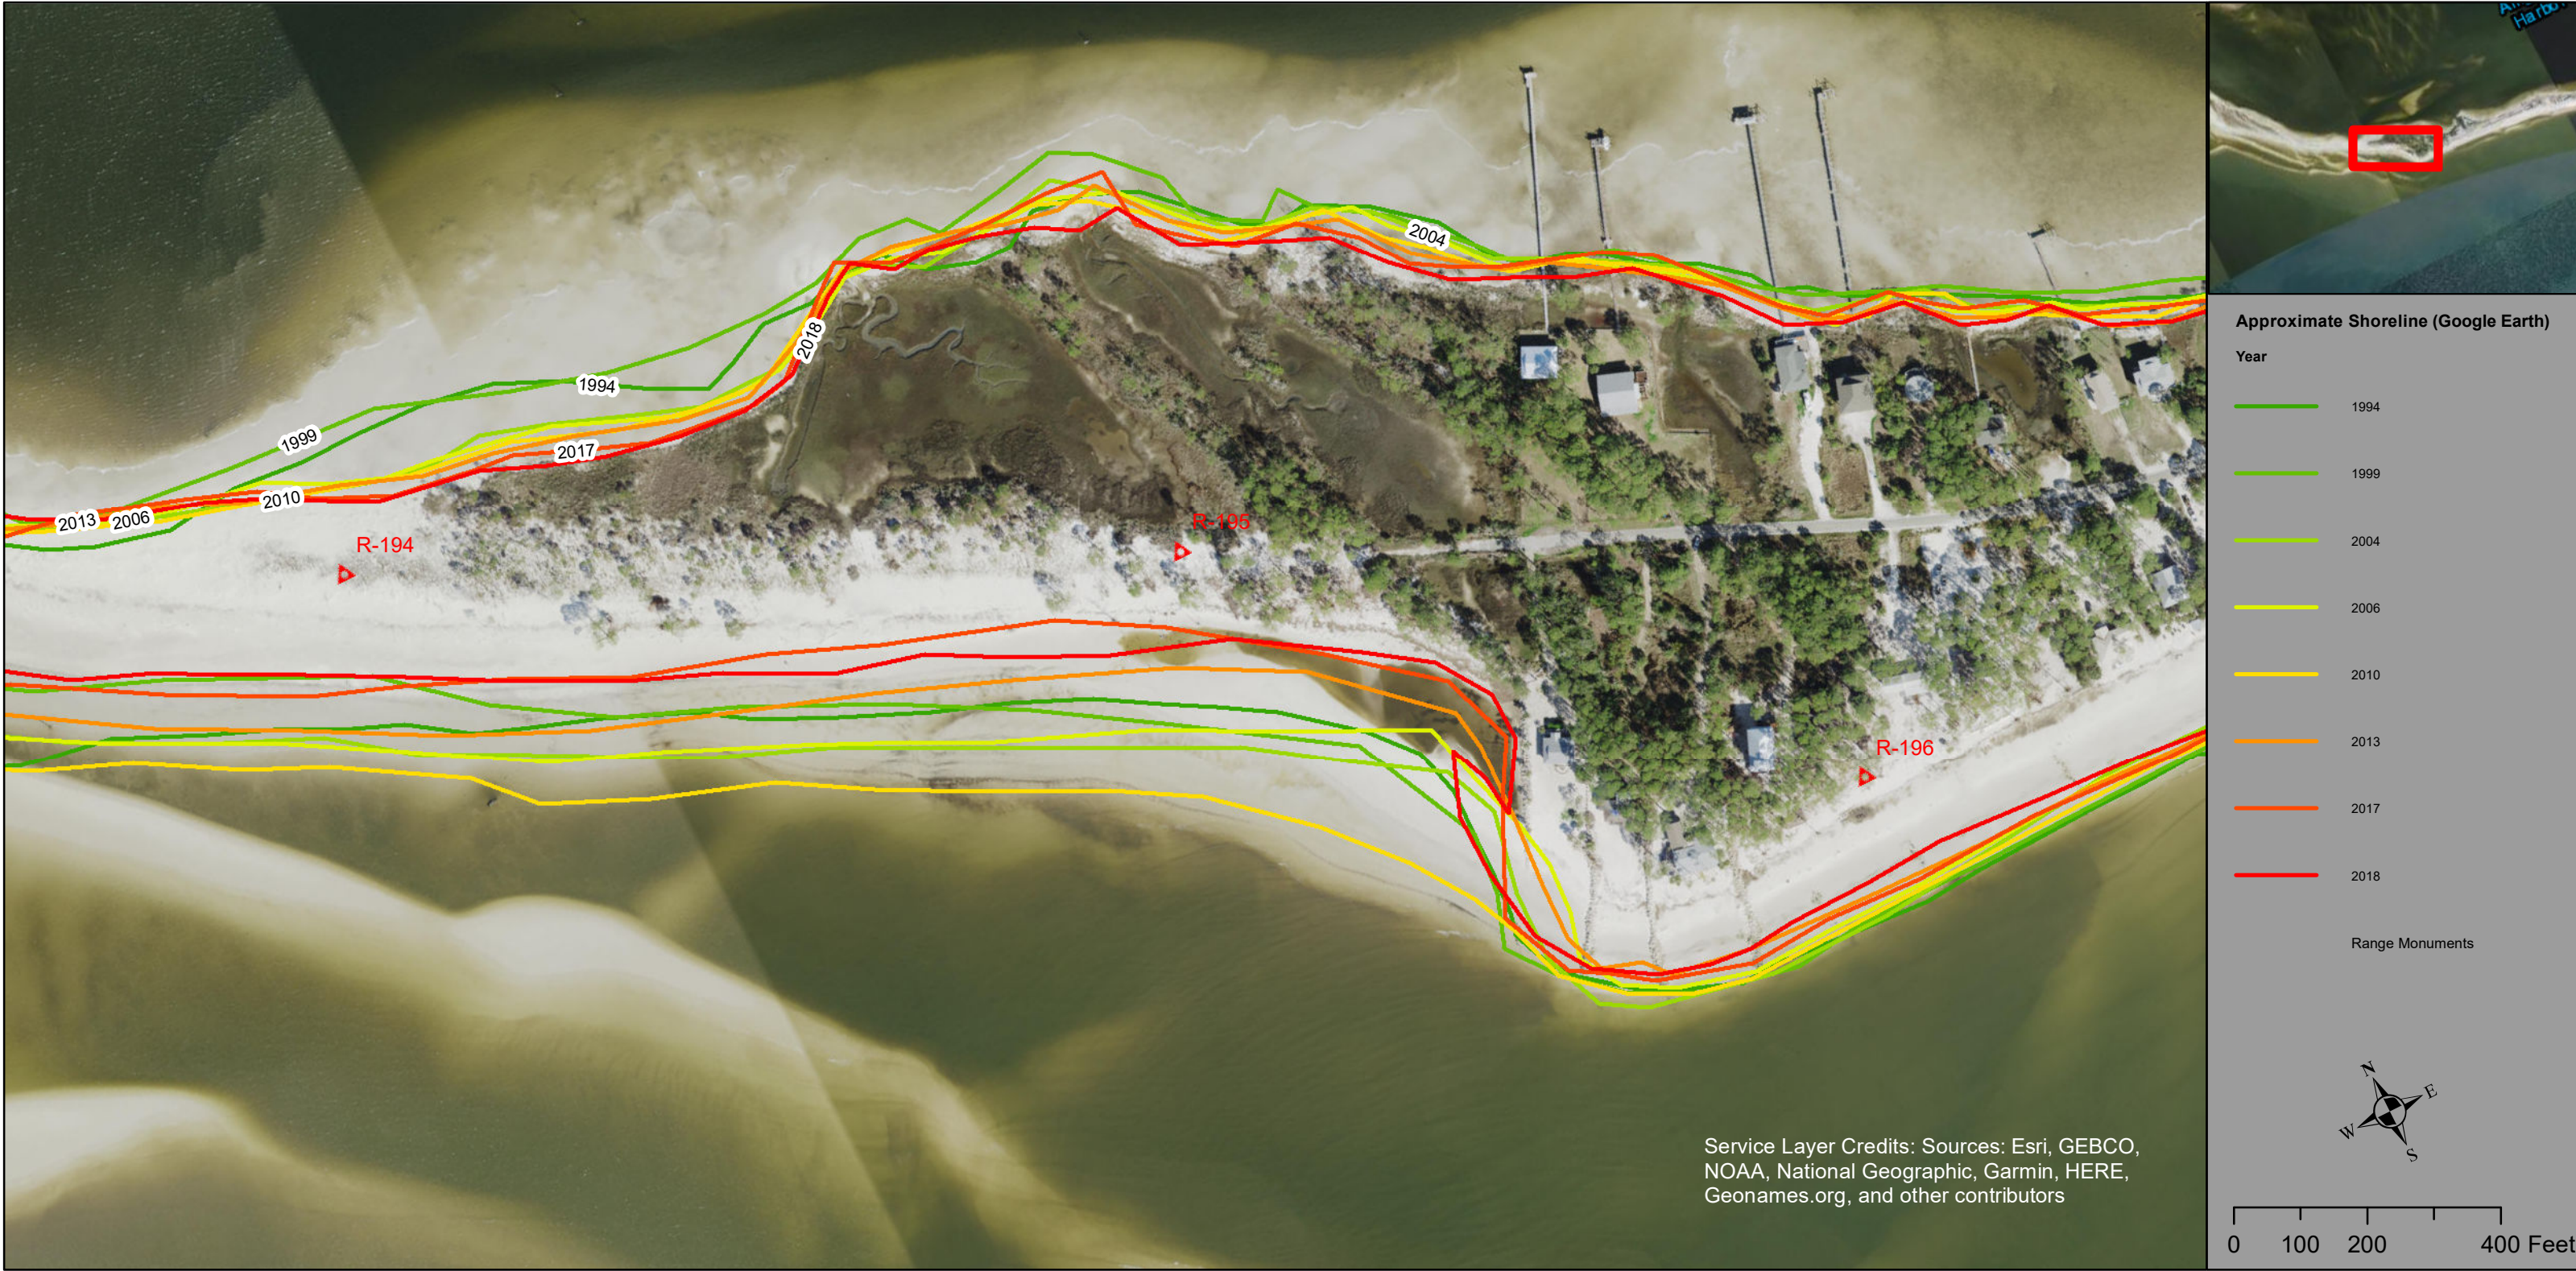
Alligator Point - Approximate Historic Shoreline Locations

Appendix C Historic Shoreline Locations (Based on Google Earth Imagery) 46

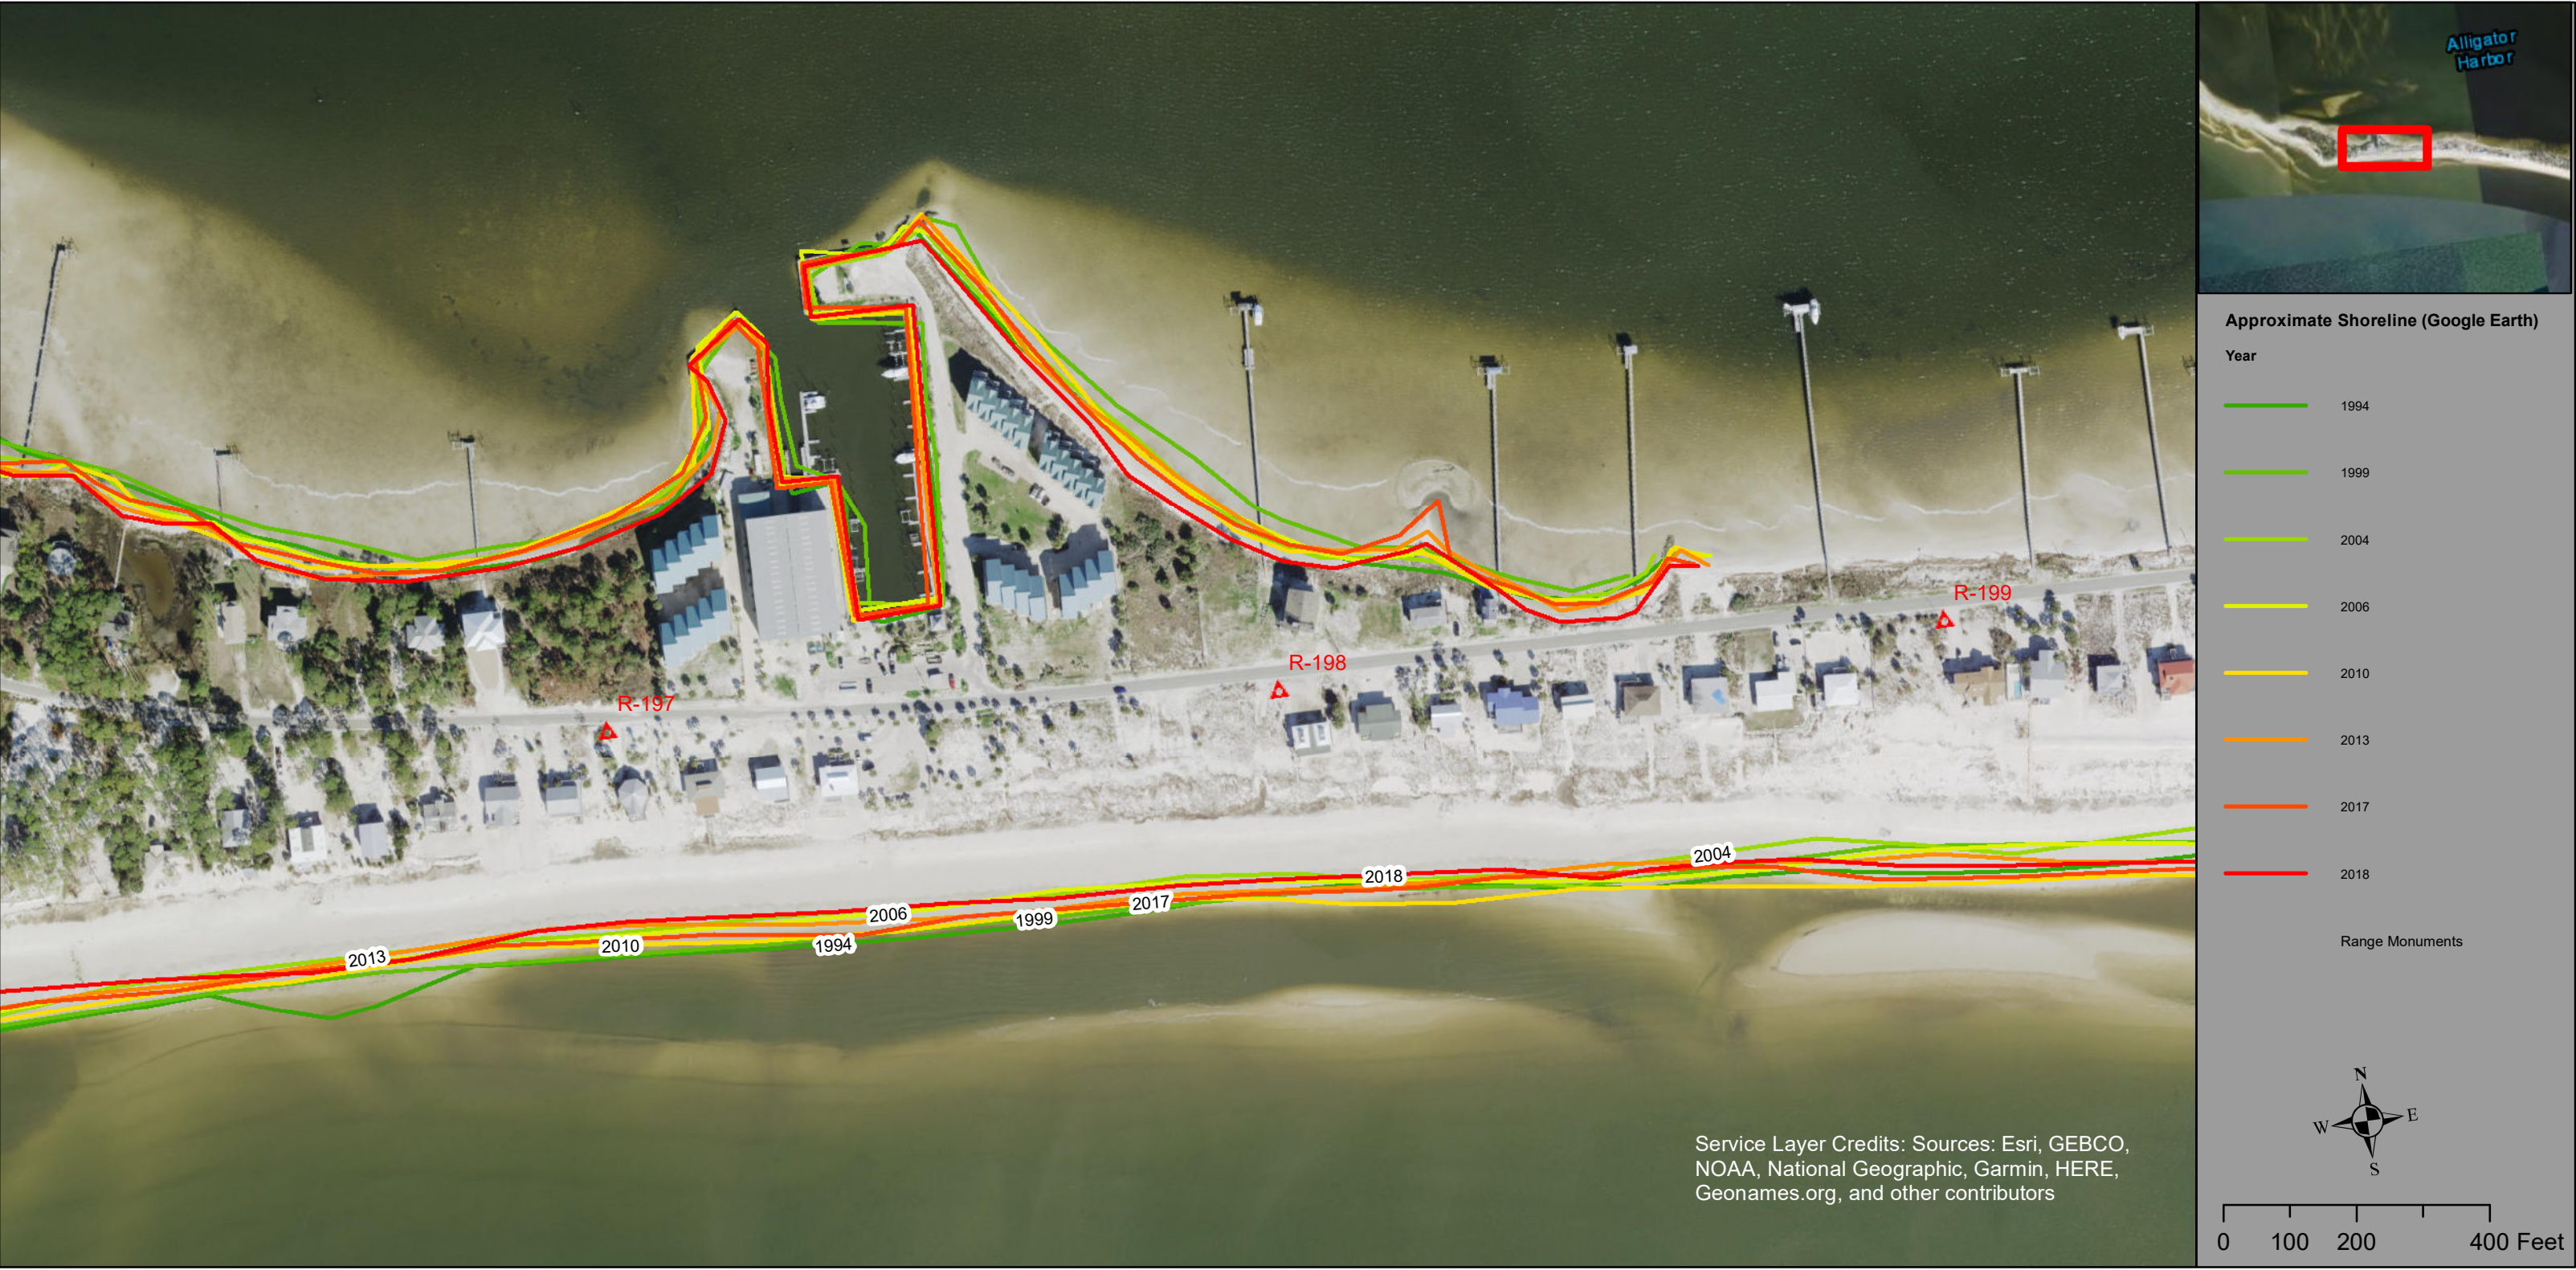
Alligator Point - Approximate Historic Shoreline Locations

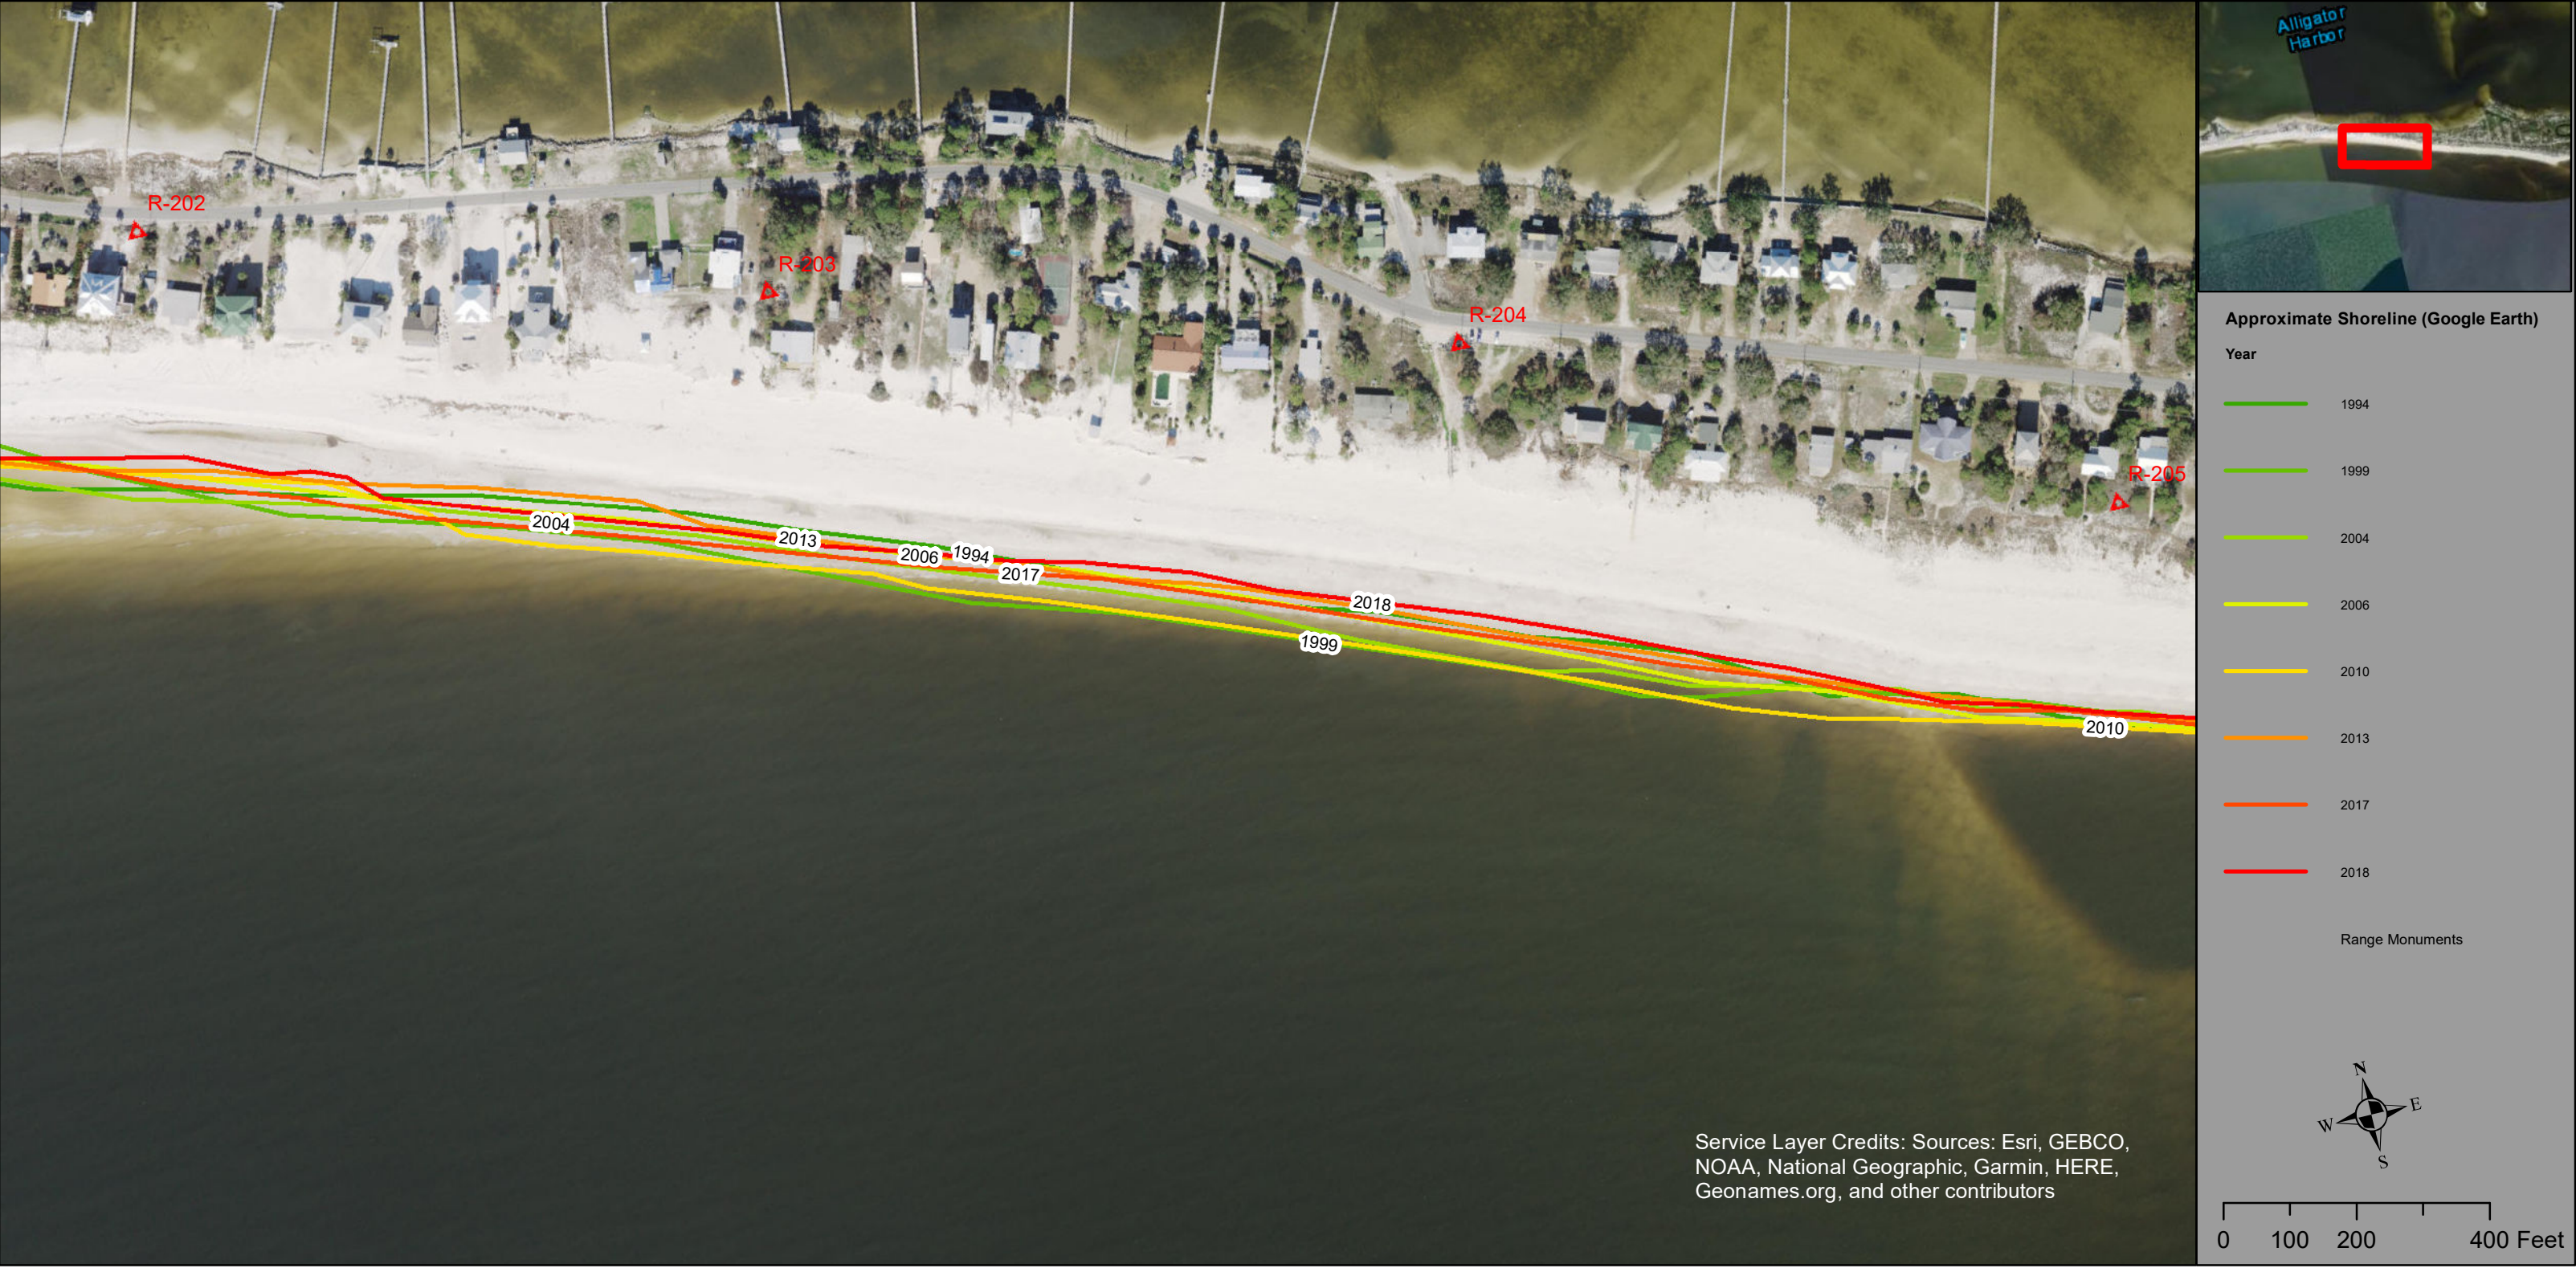
Alligator Point - Approximate Historic Shoreline Locations

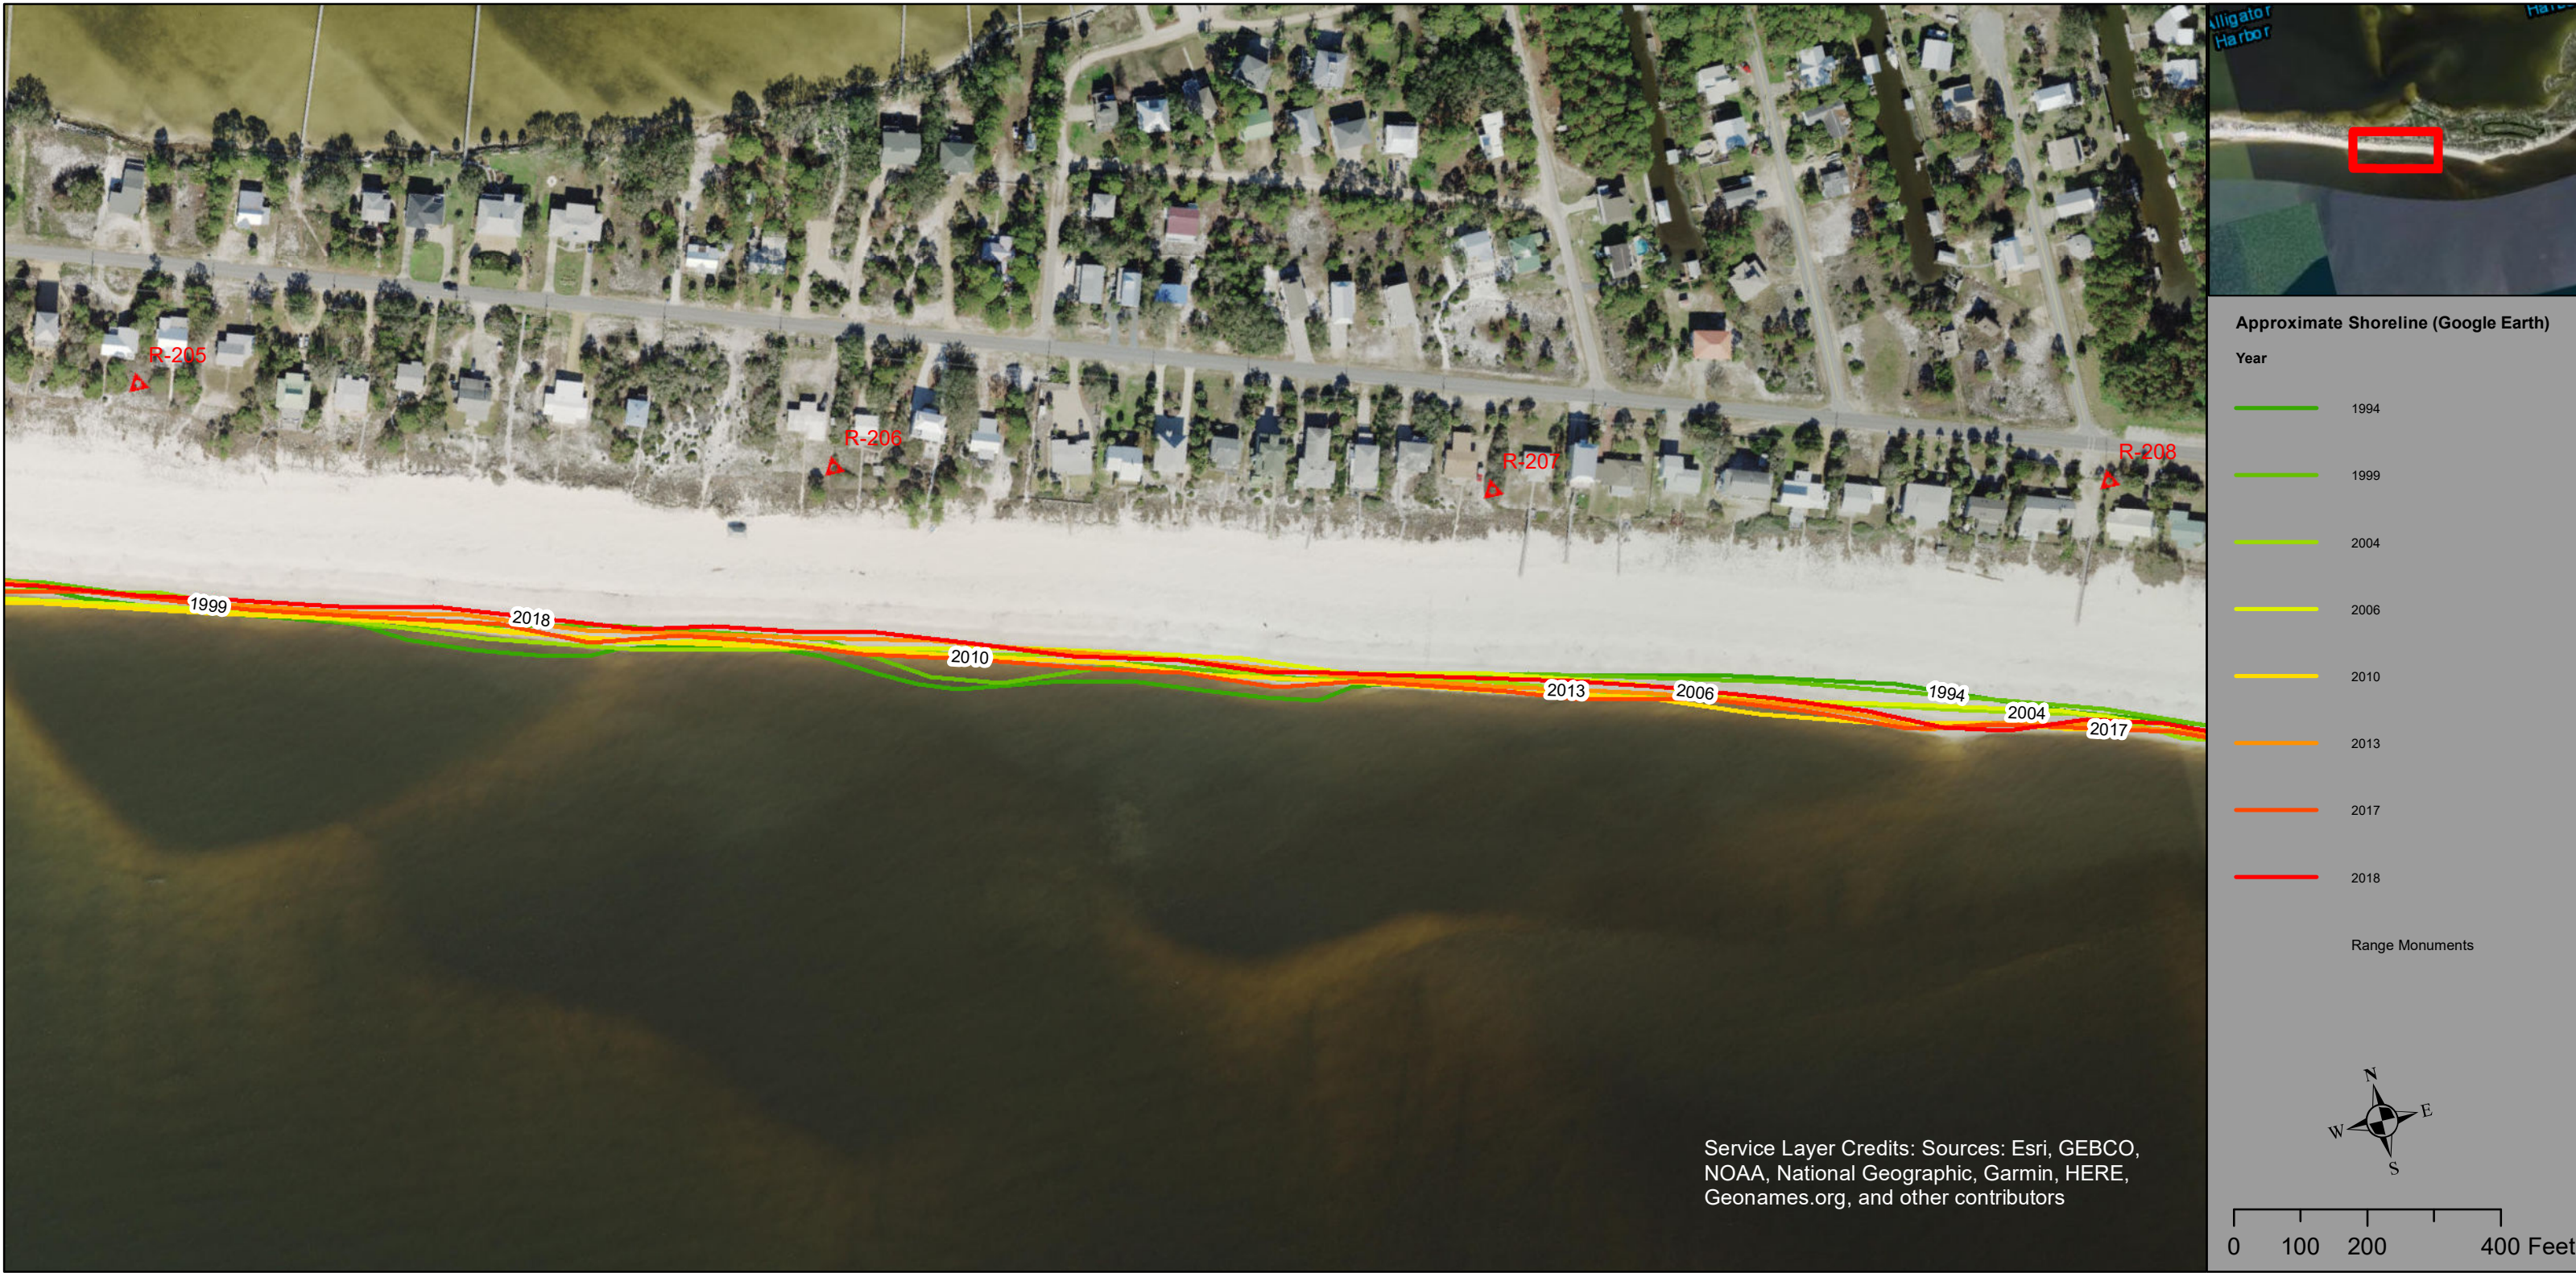
Alligator Point - Approximate Historic Shoreline Locations

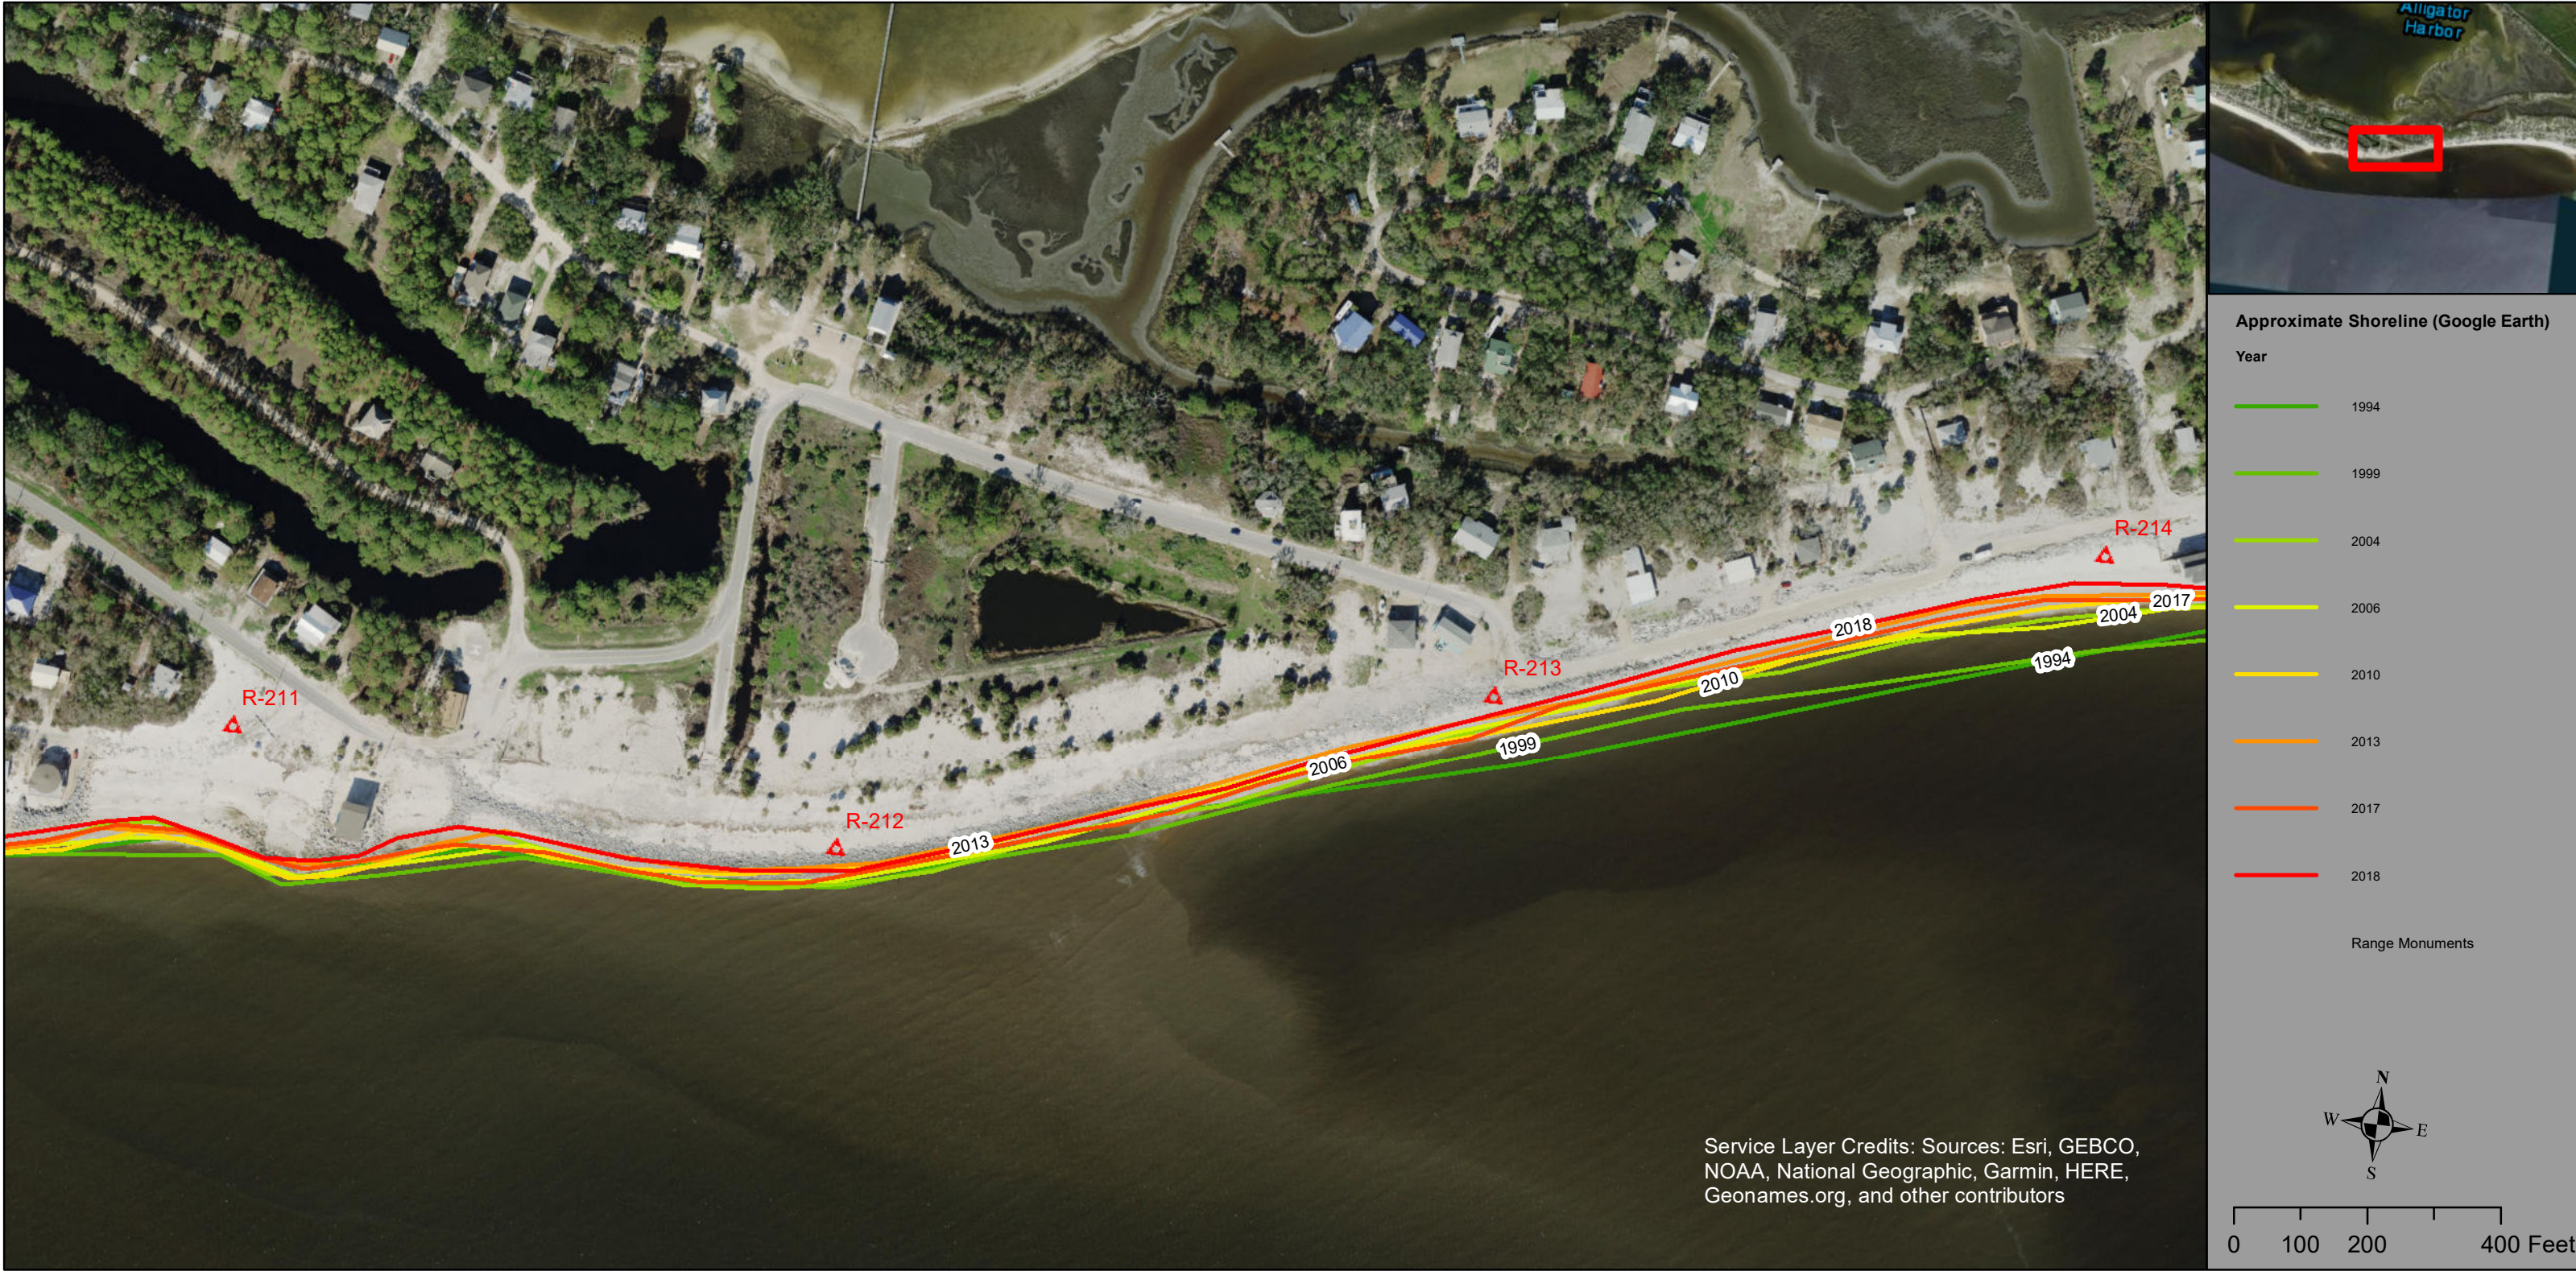
Alligator Point - Approximate Historic Shoreline Locations
