Alligator Point Coastal Resiliency Alternatives Analysis

Funded by the Florida Department of Environmental Protection (Florida Resilient Coastlines Program grant) and the Northern Gulf of Mexico Sentinel Site Cooperative.

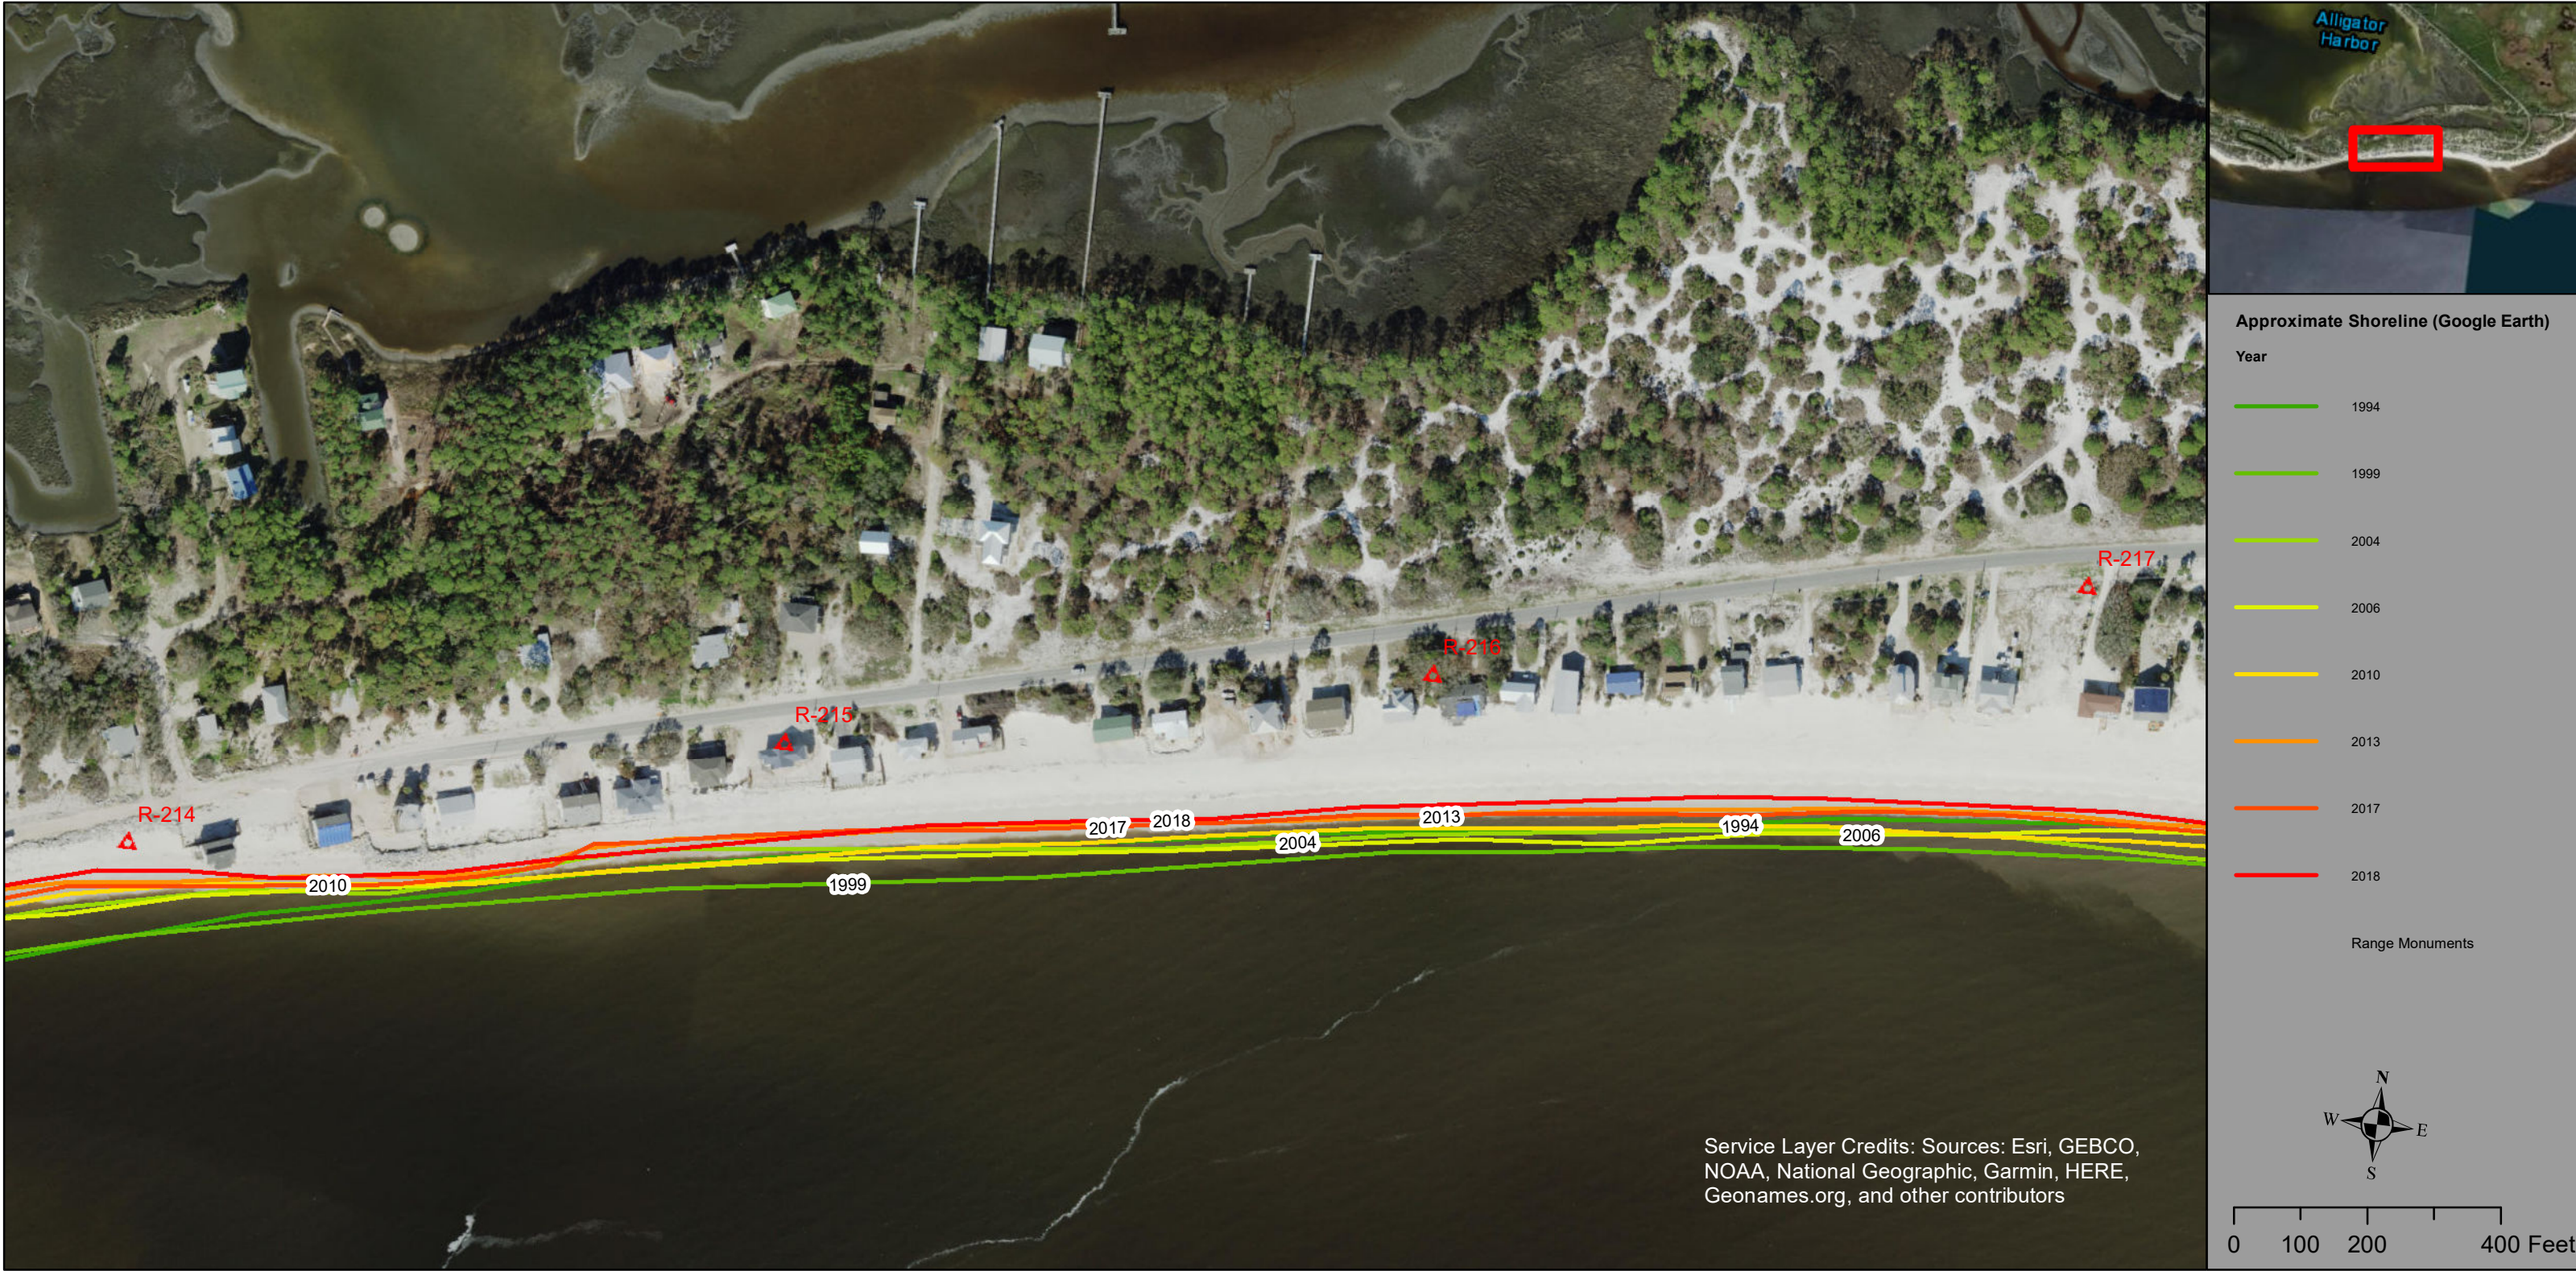
Alligator Point - Approximate Historic Shoreline Locations

Appendix C Historic Shoreline Locations (Based on Google Earth Imagery) 46

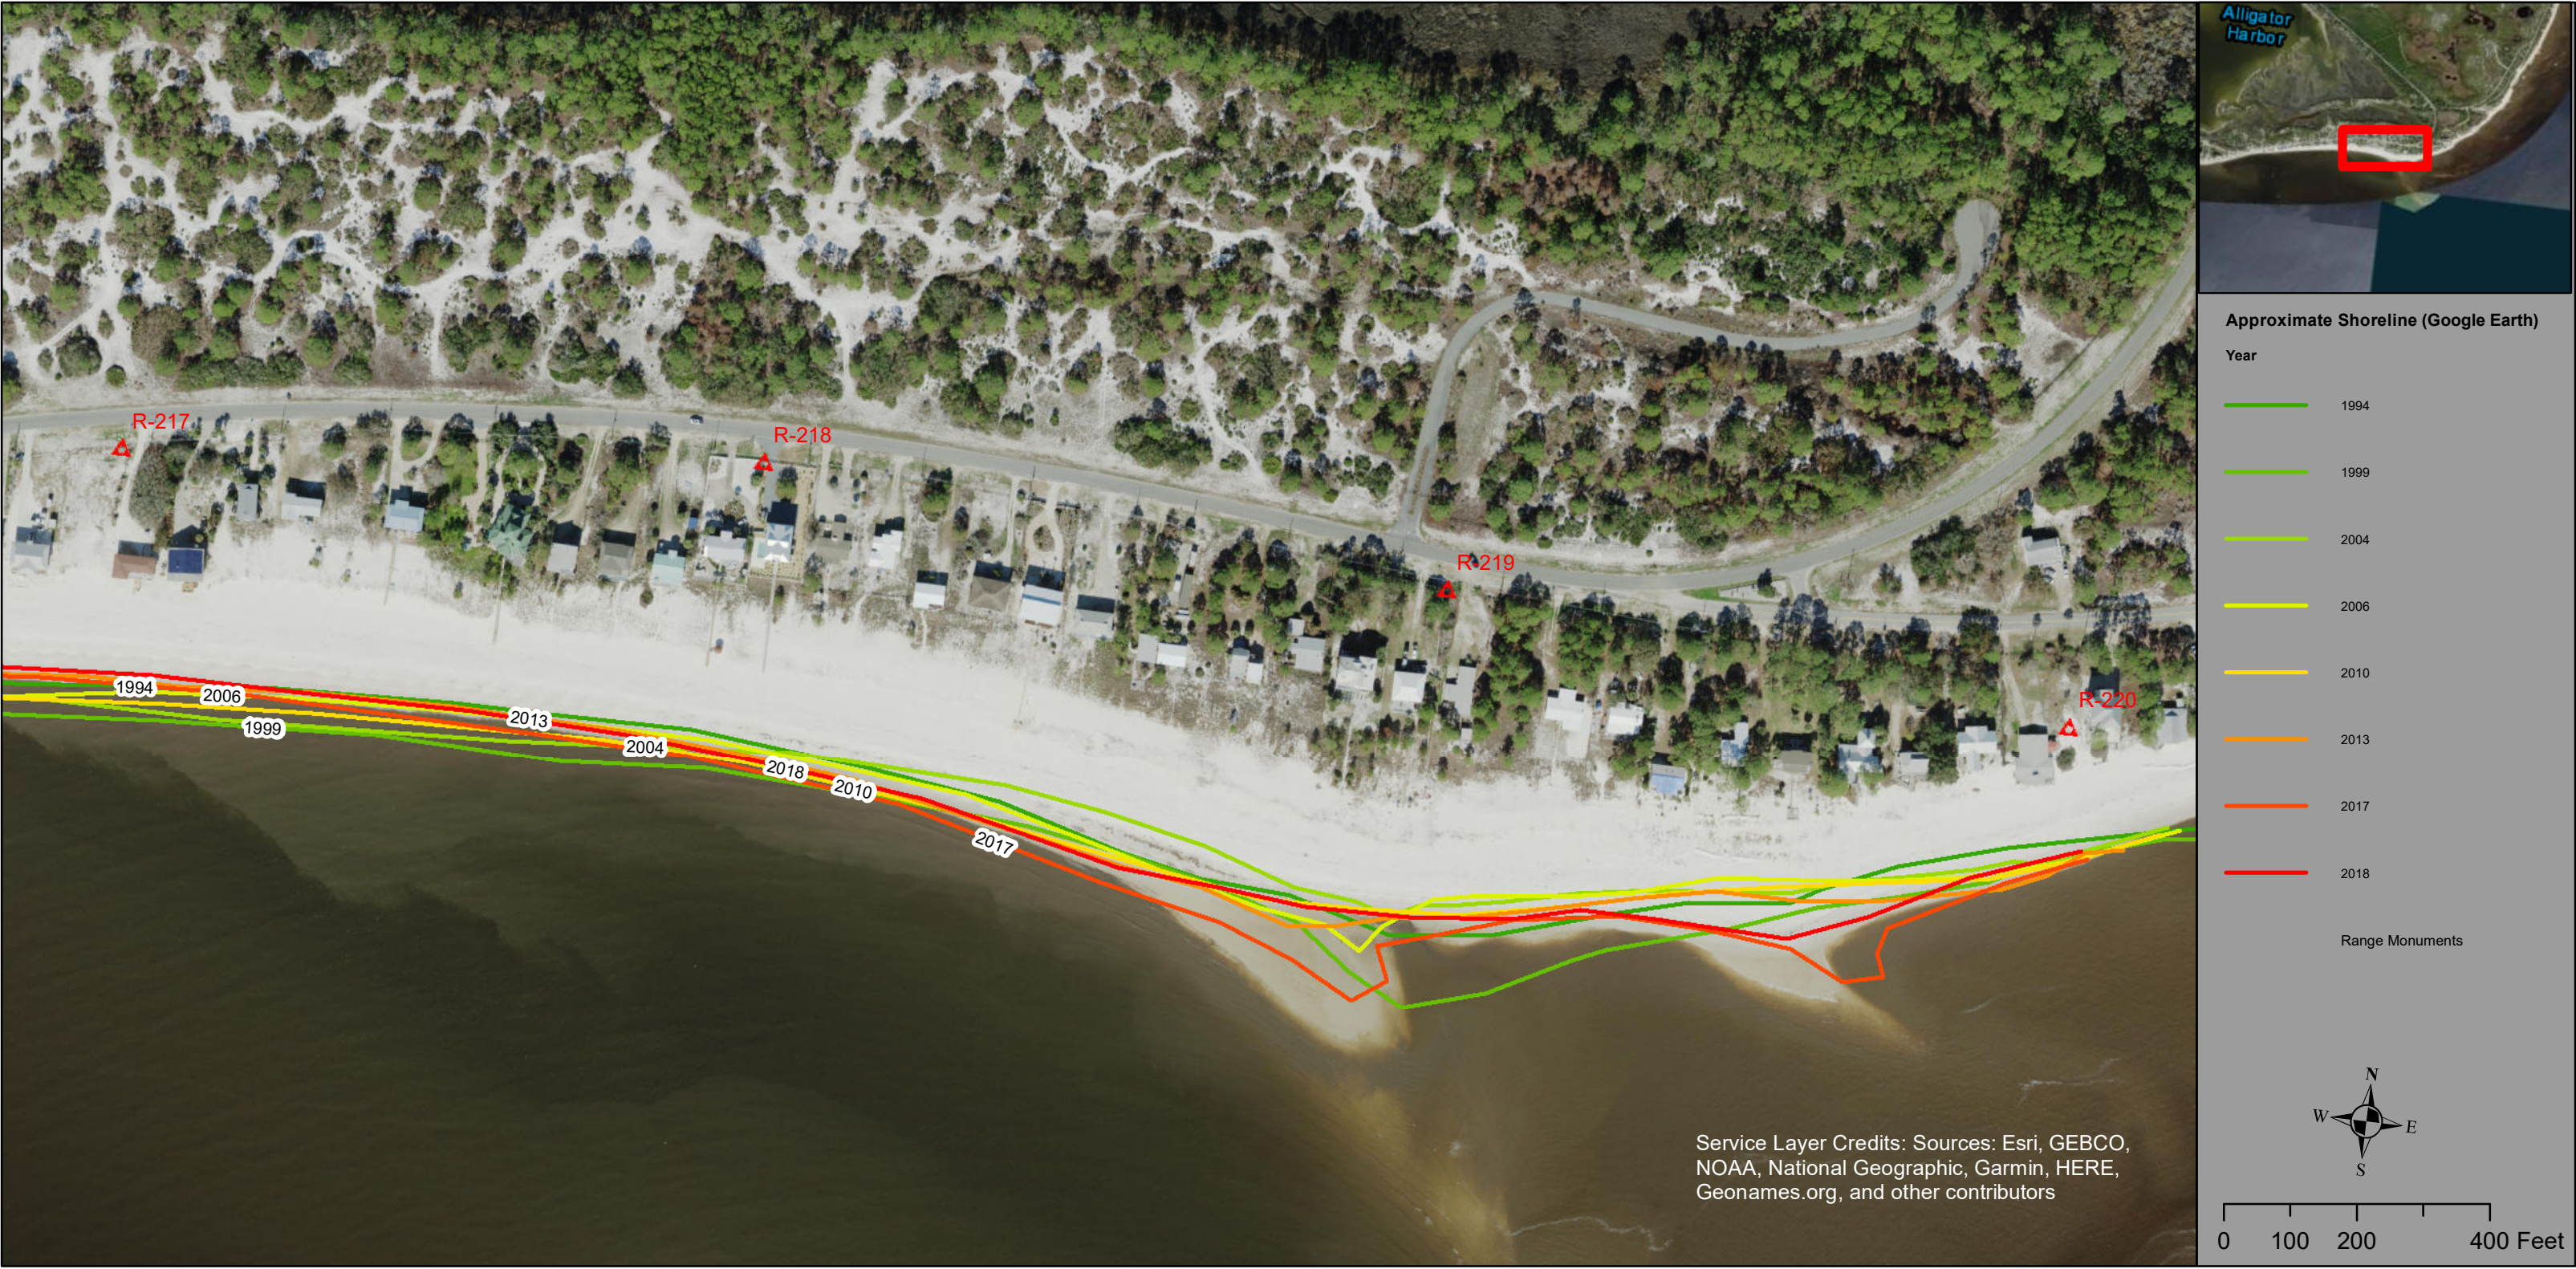
Alligator Point - Approximate Historic Shoreline Locations
